## The Slamannan Bog Restoration Project – Summary of the First Year

The Slamannan Bog Restoration Project began in September 2014 with the aim of restoring at least 150 hectares (ha) of degraded raised bog habitat in the Slamannan Plateau. The project is focused on an area of peatland called Fannyside Muir, 3km from Cumbernauld.

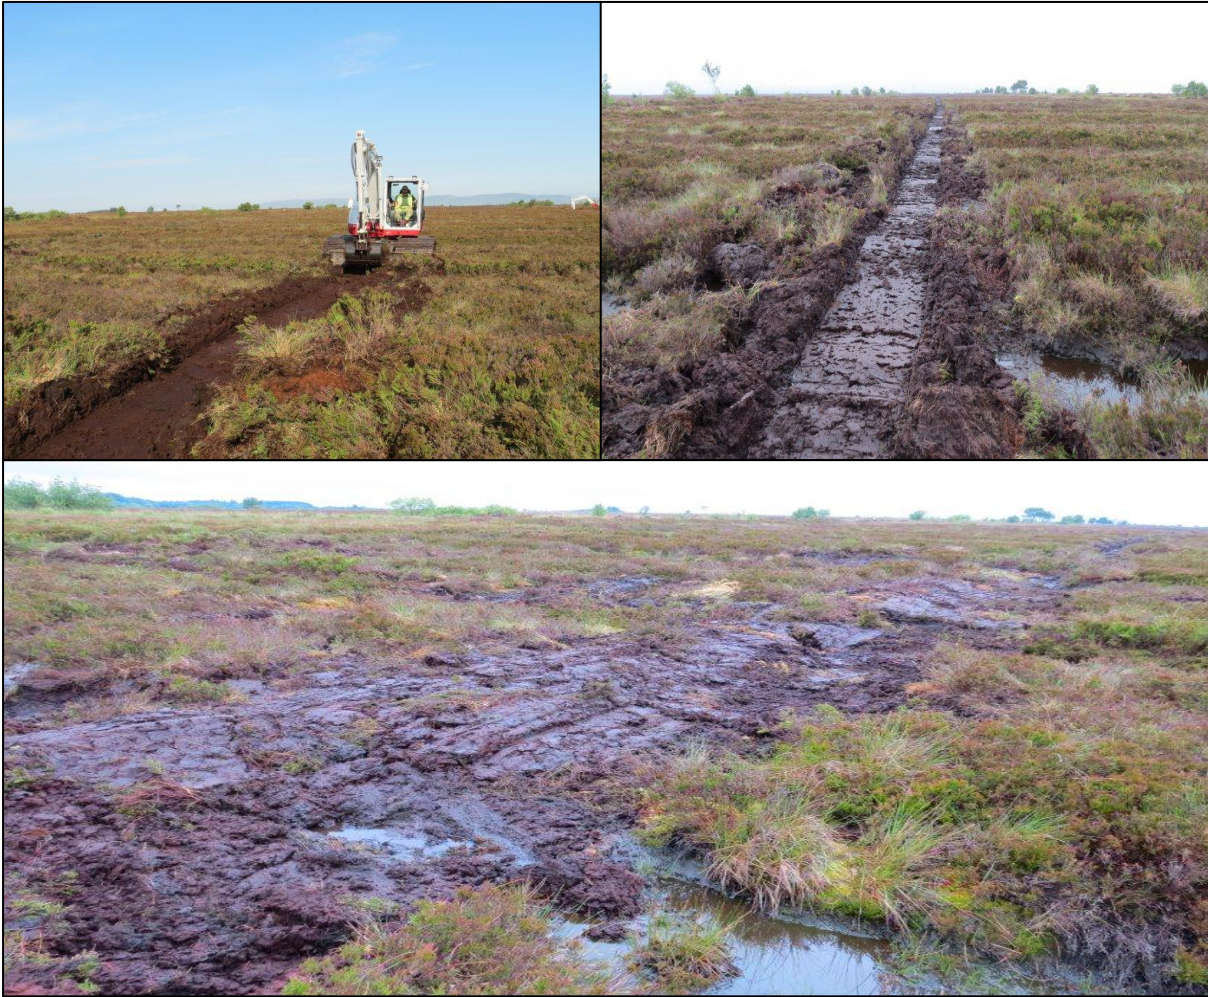
**Figure 1. Installation of trench bund in Compartment 13a.**

Top Left: Excavator installing trench bund (2 m deep). Top Right: Compressed surface of peat bund prior to capping with a dome of peat and vegetation. Bottom: 0.5m high cap of peat and vegetation along top of trench bund.

- A 670 m long trench bund was installed parallel to Fannyside Road to help retain more water on the bog (as a replacement for failed cross-tracking technique).

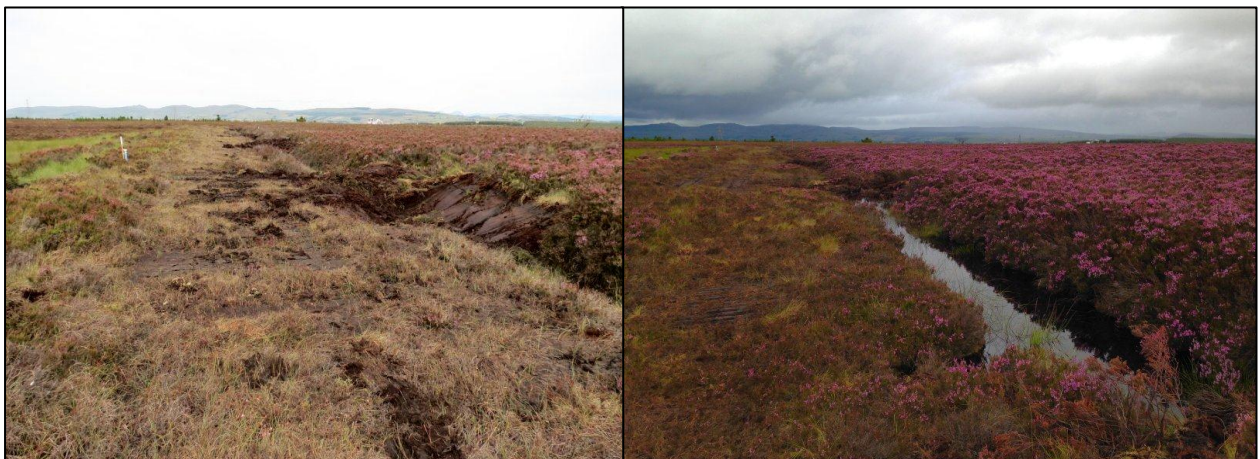
**Figure 2. Peat dams on ditch between Compartments 7 and 8.**

Left: Just after installation. Right: Late September- blocked ditches filling with water.

- During 2015 910 peat dams and 90 reinforced plastic piling dams were installed across ~110 ha of the site to raise and stabilise ground water levels on the bog.

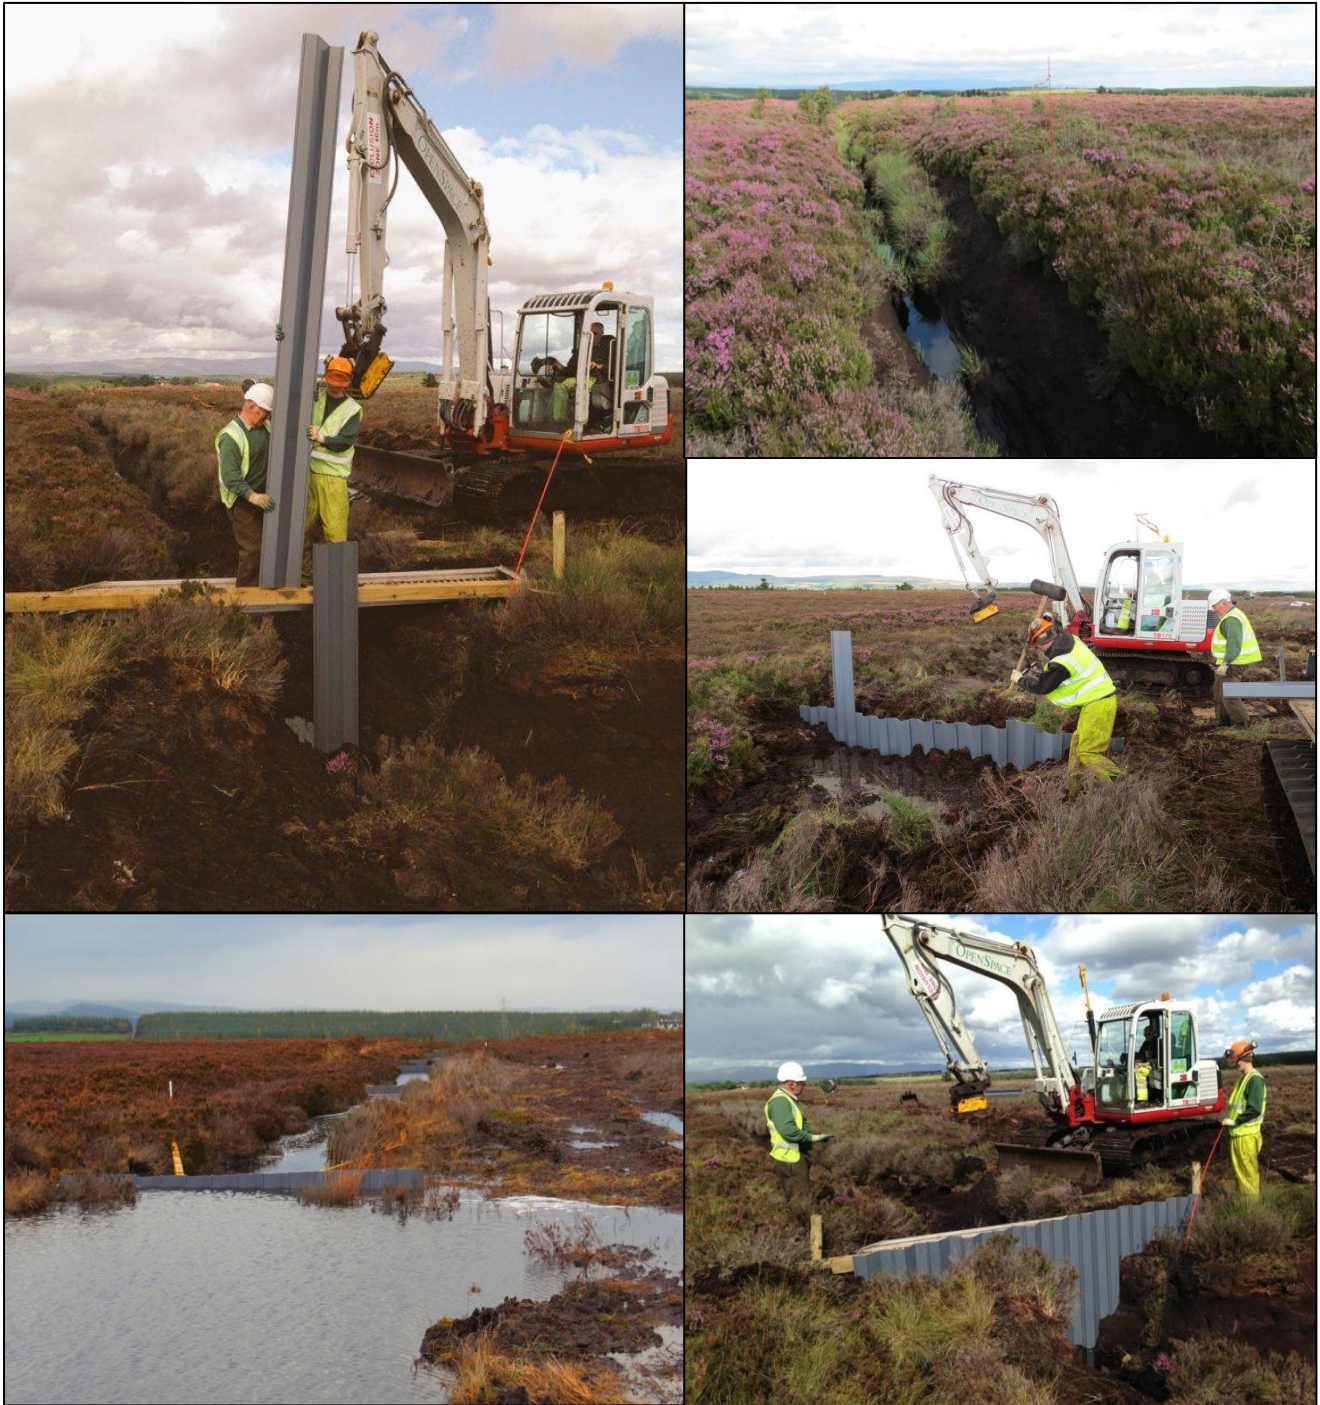
**Figure 3. Installation of 4m deep plastic piling dams on large ditch between Compartments 5 and 6 at Fannyside Muir.**

Clockwise from Top Left: First 4m piling dams being installed on deep boundary ditch.; Large eroded ditch prior to installation of piling dams.; Manual adjustment needed during installation of piling dams.(this one with peat back-filled for extra support); Supported piling dam before bracing timbers installed.; Same ditch very full of water in late October 2015.

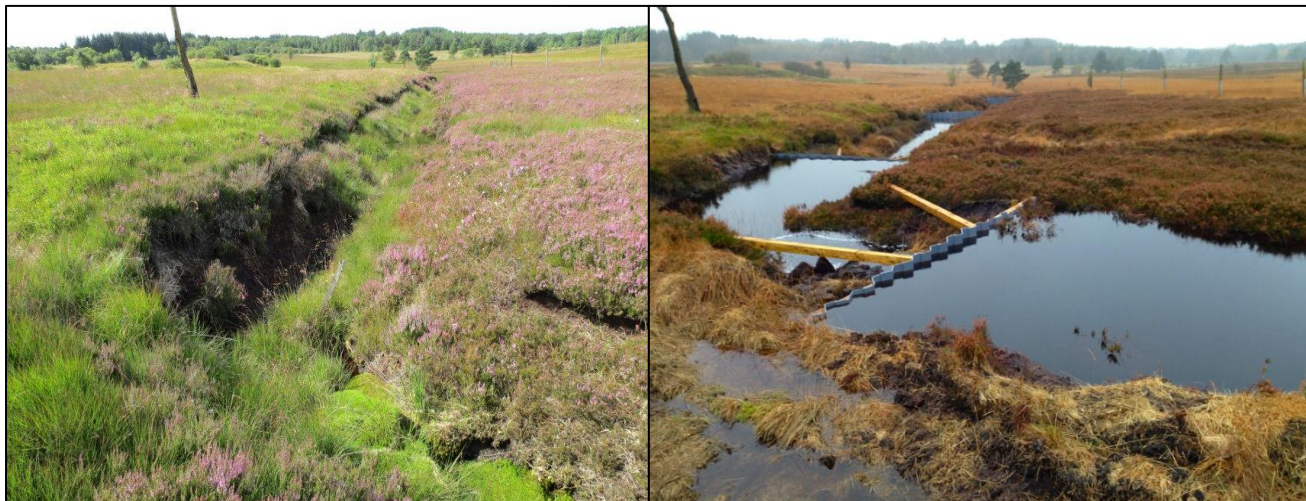
**Figure 4. Large ditch in Compartment 2 at Fannyside Muir before and after installation of reinforced plastic piling dams.**

Left: Before work began. Right: Same ditch in late October 2015 after 3 days of rain.

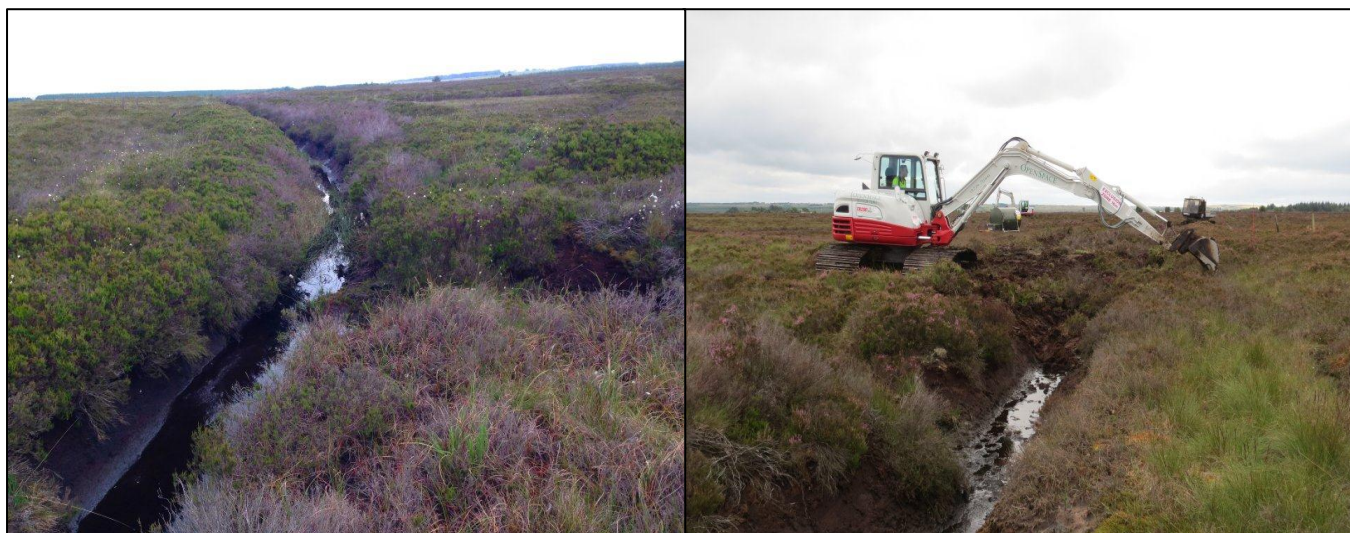
**Figure 5. Reprofiling steep-sided boundary ditch.**

Left: Before work began (Facing north-east). Right: Reprofiling and peat dam installation along ditch with excavator (Facing south).

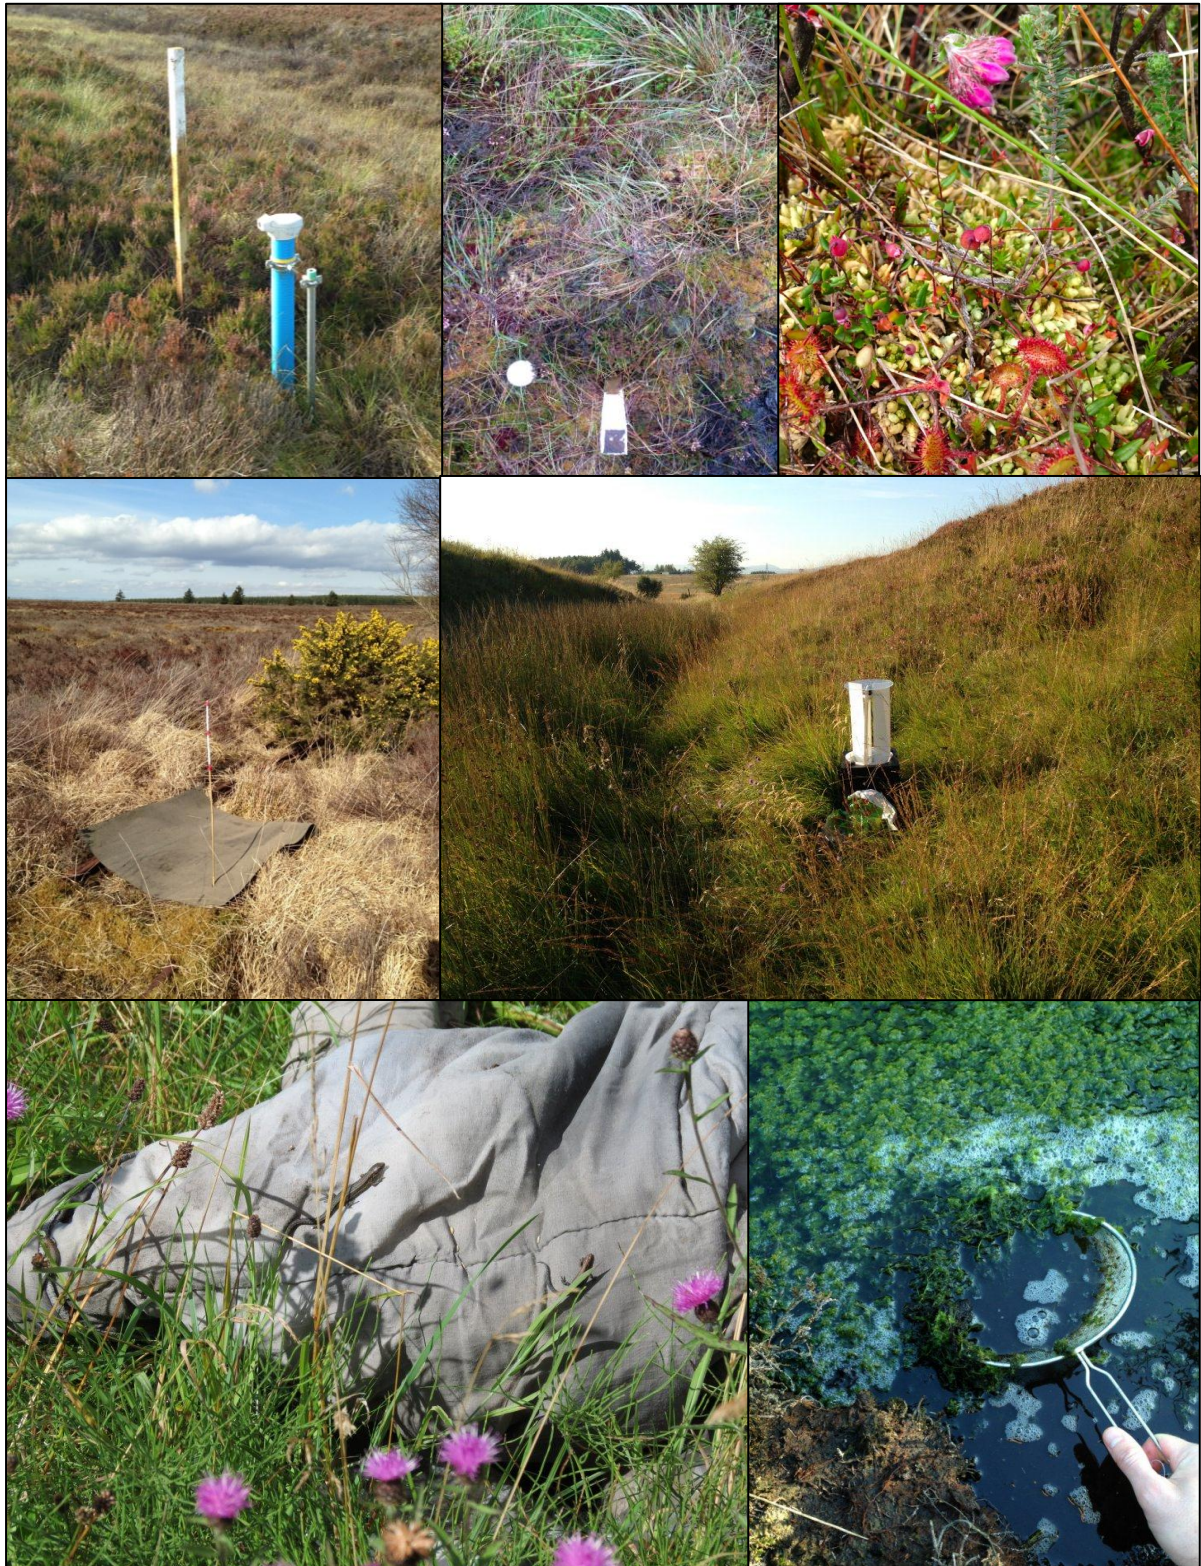
**Figure 8. Monitoring at Fannyside.**

Top Left: Water logger. Top Middle: Dipwell and mini-vegetation quadrat. Top Right: Species from control vegetation quadrat (*Sphagnum* sp., Cranberry, Cross-leaved heath, Round-leaved sundews). Centre Right: Reptile monitoring tile. Centre Left: Light trap (in gully between Compartments 1 and 2). Bottom Left: Five Common lizards (on abandoned duvet) in car park/ entrance area. Bottom Right: Sampling bog pool for aquatic invertebrates.

- Monitoring of the site included 7 fixed vegetation monitoring quadrats, 32 mini vegetation quadrats, specialist breeding bird and protected species surveys, reptile surveys, moth trapping, butterfly timed counts and a variety of other invertebrate surveys (aquatic surveys, pitfall traps, sweep netting).
