SUMMARY

The Slamannan Bog Restoration Project began in September 2014 with the aim of restoring at least 150 hectares (ha) of degraded raised bog habitat in the Slamannan Plateau. The project is focused on an area of peatland called Fannyside Muir, 3km from Cumbernauld.

Progress in the third year of the project is summarised below:

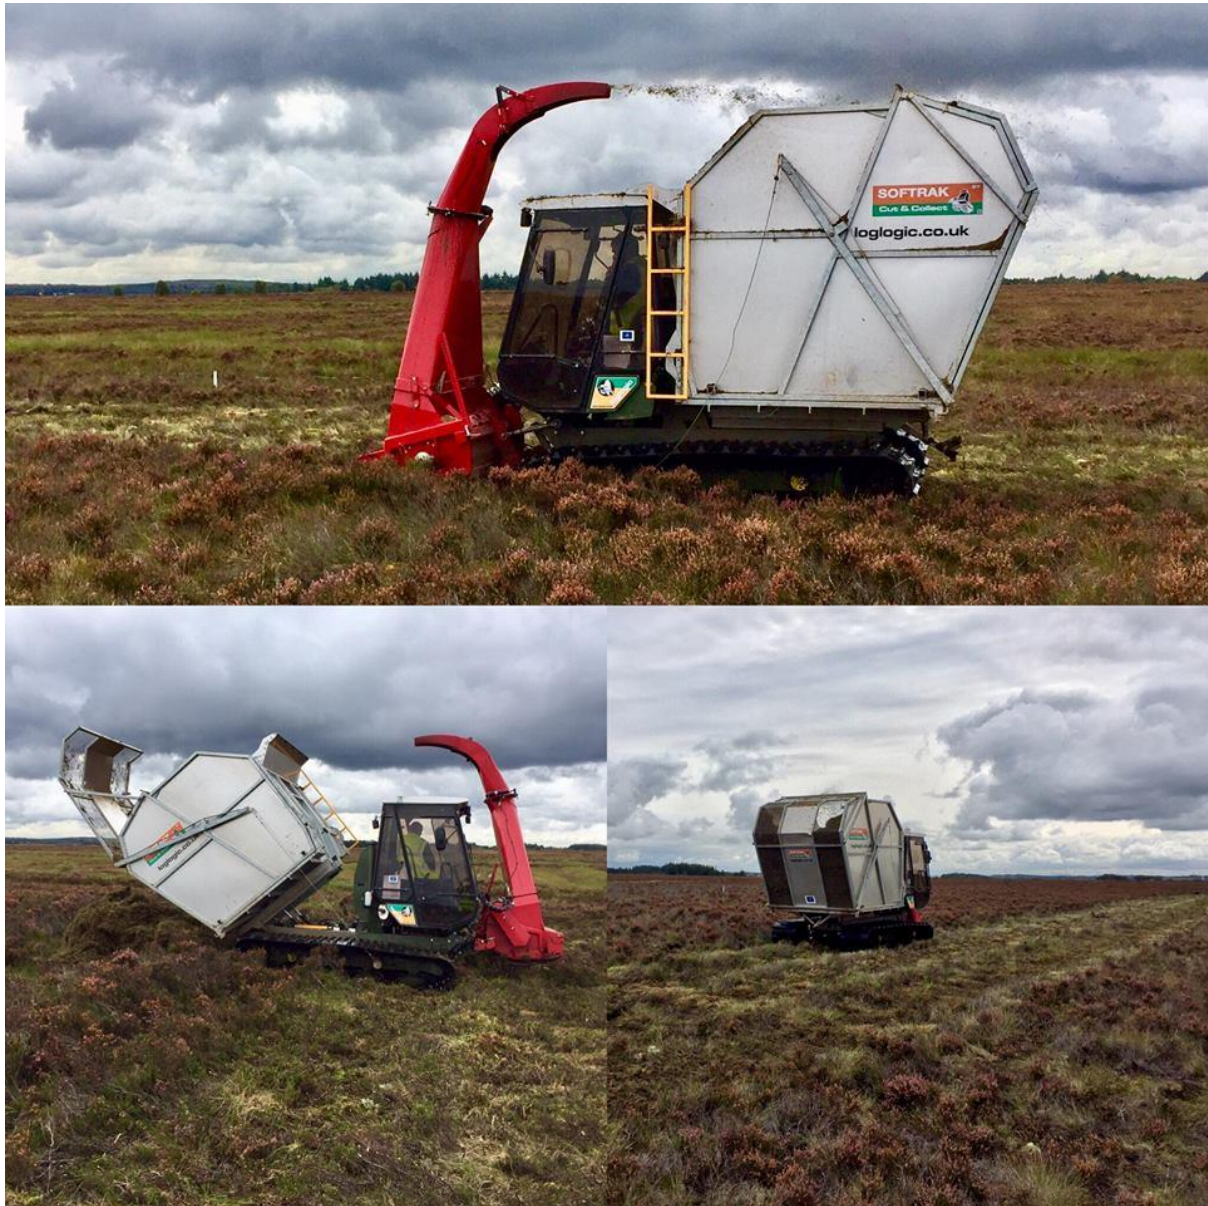
Figure 1. Heather cutting in Compartment 7.

Top: Softrak Loglogic 'Cut and Collect' system harvesting heather to reduce evapotranspiration. Heather brash added to surrounding ditches to help with ditch occlusion. September 2017. Bottom Left: Dumping heather brash into small ditch to help with occlusion. Bottom Right: Softrak Loglogic 'Cut and Collect' system harvesting heather. Area of bog in foreground has been cut, and brash visible in the collection cage

- Heather cutting was carried out in September 2017 to help reduce evapotranspiration from areas of tall woody heather. Cutting was undertaken by trained SNH/ EcoCo LIFE staff using a Softrak Cut & Collect system. Due to the time of year, the area that could be cut was limited prior to the return of Taiga Bean geese in late September. Approximately 1.2 ha of heather in Compartment 7 was cut, with the heather cuttings added to surrounding ditches to help with ditch occlusion.
